PI 1456 For technical personnel only! Page 1/1

## Outside oversize engine bearing Repair solution for MAN D2066/D2866/D2876

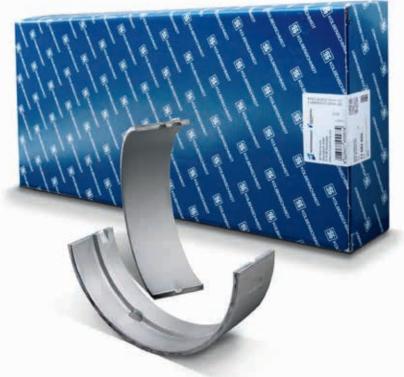
The main bearing blocks of the engines mentioned above cannot be repaired in a conventional way due to the cracked bearing caps. Motorservice offers a special set of outside oversize engine bearings to enable these engine blocks to be fixed.

This engine bearing set with larger outside diameter allows the engine reconditioner to condition the faulty main bearing blocks of the engine block.

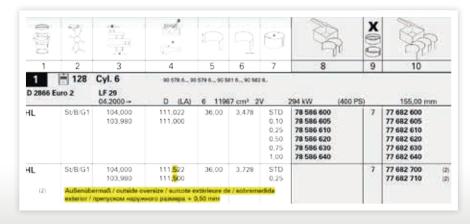
Catalogue example – outside oversize engine bearing set for MAN D2866
